# Manhole Inspection Summary

Manhole # S33A\_\_032MH

Insp Date: **10/11/07 10:11 AM**

**Location** Address: **226 MONUMENT ST**

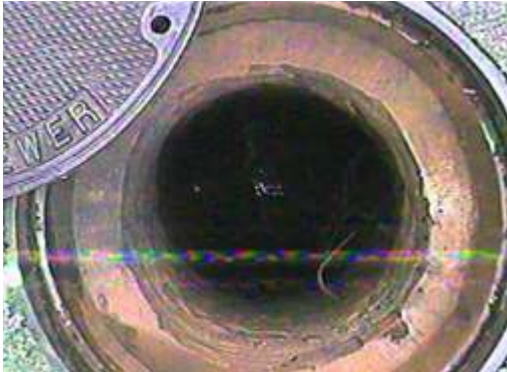
Top View

Offset: **3** (in.)

FRAME OFFSET

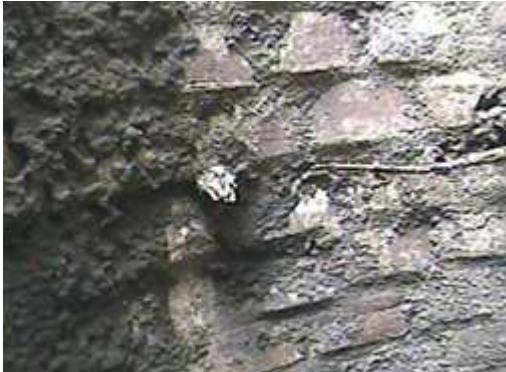
Defect 1

Count: **9** Missing: **2** ☒ **Corroded**

MISSING / CORRODED RUNG

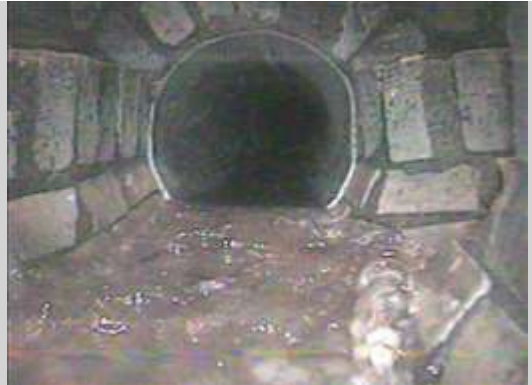
12 O'Clock Outflow

12 in. Circular Gravity Sewer  
Pipe Out @ 12 O'Clock

Pipe Height: **8.4** (in.) Rod and Bar  
Pipe Material: **Clay** ☐ Pipe Lined  
Invert Depth: **15.19** (ft.) Flow Characteristics: **Fast**  
Deposits: ☒ None ☐ Mud ☐ Sludge ☐ Debris ☐ Grease  
Silt Depth: (in.) Deposits Extent:  
Infiltration: **None** Pipe Seal Cond: **Sound**

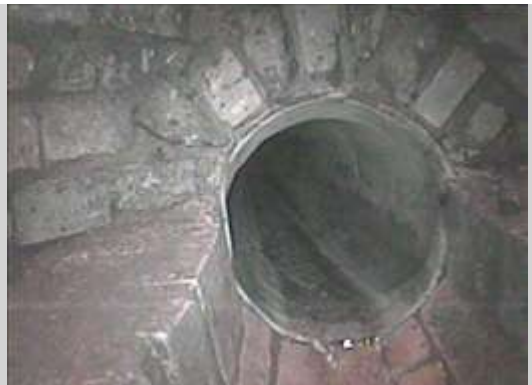
3 O'Clock Inflow

10 in. Circular Gravity Sewer  
Pipe In @ 3 O'Clock

Pipe Height: **7.2** (in.) Rod and Bar  
Pipe Material: **Clay** ☐ Pipe Lined  
Invert Depth: **14.84** (ft.) Flow Characteristics: **Fast**  
Deposits: ☒ None ☐ Mud ☐ Sludge ☐ Debris ☐ Grease  
Silt Depth: (in.) Deposits Extent:  
Infiltration: **None** Pipe Seal Cond: **Sound**

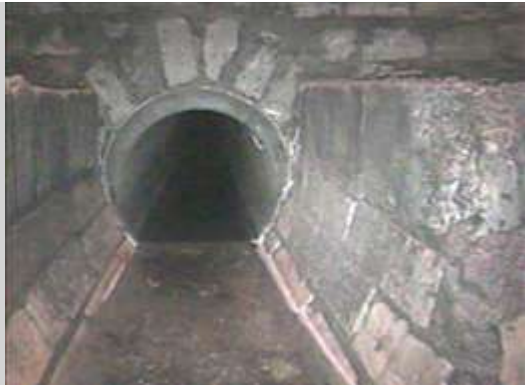
6 O'Clock Inflow

10 in. Circular Gravity Sewer

Pipe In @ 6 O'Clock

Infiltration: **None** Pipe Seal Cond: **Sound**

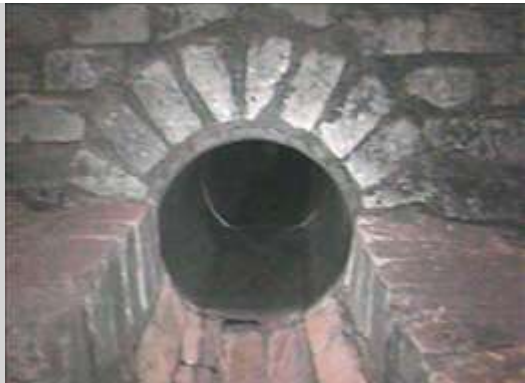
9 O'Clock Inflow

10 in. Circular Gravity Sewer

Pipe In @ 9 O'Clock

Infiltration: **None** Pipe Seal Cond: **Sound**
